# Army Lodging Wellness Recommendation

## Final Submittal - USMA West Point

May 21, 2004

## USMA West Point

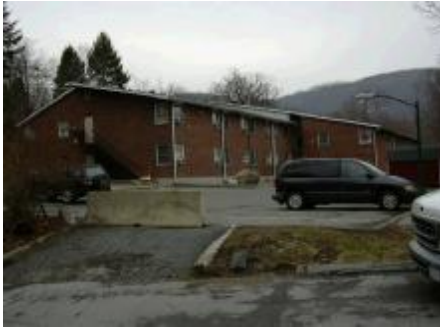
*Bldg 785  
Exterior View  
US Military Academy  
West Point, NY*

Building 785, constructed in 1973, is a two-story brick structure housing 24 existing extended stay rooms and 11 family suites.. This building is in poor condition and does not provide appropriate support spaces. The cost to make condition assessment improvements will exceed 50% of the replacement cost.

- Analysis: The original wood decking is attached to sloped wood rafters and is in good condition. The wood soffit is showing signs of failure and is in poor condition. The gutters are exterior to the roof with exposed downspouts appear to be original and in poor condition.
- Recommendation: Replace and repaint the soffit and replace the gutters and downspouts.

- Analysis: The exterior wall construction is brick veneer and is in good condition.
- Recommendation: No corrective action required.

Our recommendation is to remove building 785 from the Lodging inventory, allowing the installation to determine an alternate use for this facility. This facility will be removed from the USMA West Point Wellness Solution and Lodging Master Plan.

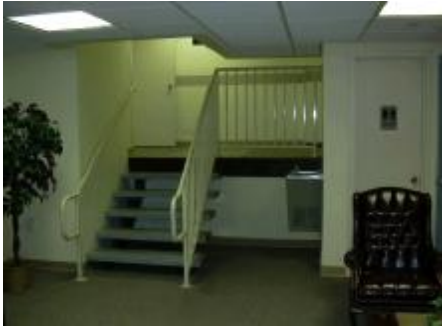
Bldg 785  
Interior Stairs  
US Military Academy  
West Point, NY

- Analysis: The exterior stairs are metal and are failing. The interior stairs are a combination of the original steel and concrete tread and a short flight of fire resistant wood replaced in 2001. The interior stairs are in good condition.
- Recommendation: Replace the exterior stairs.

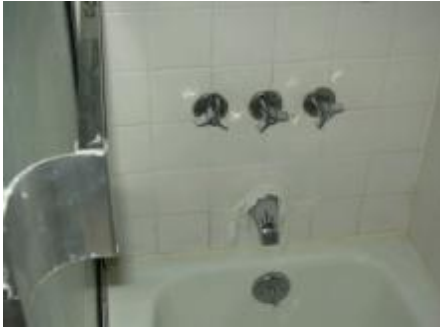
**Bldg 785**  
**Shower/Tub Fixtures and Ceramic**  
**Tile**  
**US Military Academy**  
**West Point, NY**

- Analysis: The guest room interior walls are painted drywall without any vinyl wall covering and are in poor condition. The bathroom walls are ceramic tile and painted drywall and are in poor condition. The small lounge area, hallways, common, storage and back-of-house areas are painted drywall and are in poor condition.
- Recommendation: Install vinyl wall covering in the guest rooms, bathrooms, hallways, lounge, and common areas; replace the ceramic wall tile in the bathrooms and paint the back-of-house areas.

- Analysis: The plumbing fixtures consist of chrome plated brass faucets for the lavatory, bathtub, and kitchen sink. The lavatory and bathtub fixtures appear original and the kitchen sinks fixtures are approximately ten years old. The lavatory and bathtub fixtures are in poor condition, while the kitchen sink fixtures are in good condition. The bathroom sinks, showers, and water closets appear original and are in poor condition. The stainless steel kitchen sink is in good condition.
- Recommendation: Replace the bathtub, bathroom sink and water closet and all fixtures.

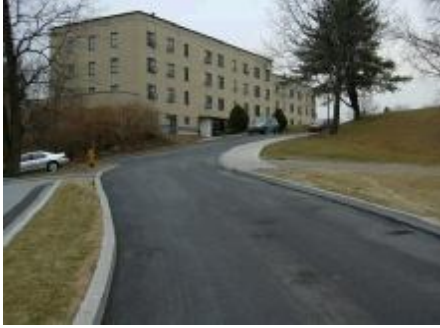
*Bldg 2113  
Main Lodging Exterior View  
US Military Academy  
West Point, NY*

• Condition Assessment Cost	\$3,369,726
• Replacement Cost	\$6,330,759
• Condition Assessment to Replacement Cost Ratio	53.23%

Because the Condition Assessment to Replacement Cost Ratio is greater than 50.00%, repair of Building 2113 is not recommended.
